Manhole Inspection Summary

Manhole # S47MM_038MH

Insp Date: **2/24/10 2:57 PM**

Location Address: **Homestead st**

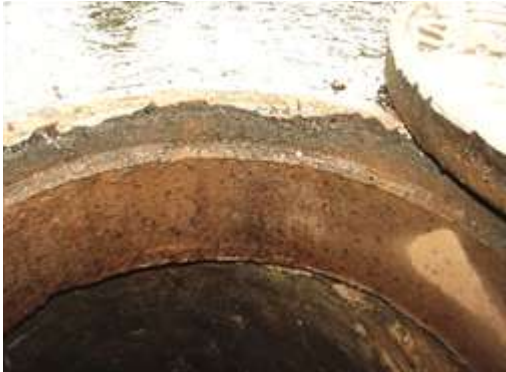
Defect 1

Frame Offset: **5** (in.) Condition: ☐ Sound ☐ Cracked ☒ **Leaks**

frame leaks

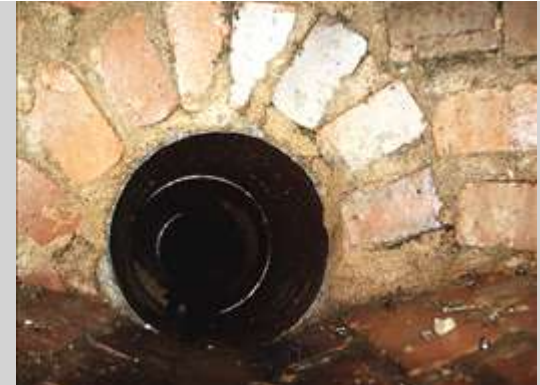
12 O'Clock Outflow

Pipe Height: **12** (in.) Rod and Bar (Angled)
Pipe Material: **Clay** ☐ Pipe Lined
Invert Depth: **8.33** (ft.) Flow Characteristics: **Slow**
Deposits: ☒ None ☐ Mud ☐ Sludge ☐ **Debris** ☐ Grease
Silt Depth: (in.) Deposits Extent:
Infiltration: **None** Pipe Seal Cond: **Sound**

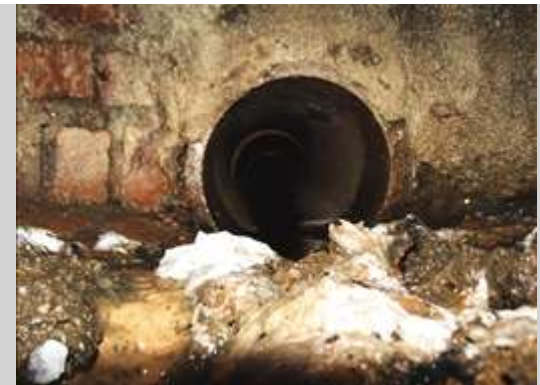
6 O'Clock Inflow

Pipe Height: **12** (in.) Rod and Bar (Angled)
Pipe Material: **Clay** ☐ Pipe Lined
Invert Depth: **8.00** (ft.) Flow Characteristics: **Slow**
Deposits: ☐ None ☐ Mud ☐ Sludge ☒ **Debris** ☐ Grease
Silt Depth: **5** (in.) Deposits Extent: **Heavy**
Infiltration: **None** Pipe Seal Cond: **Sound**
